**EXPERIMENTAL INVESTIGATION OF THE
INTERACTION OF MOISTURE, LOW TEMPERATURE, AND
LOW LEVEL IMPACT ON GRAPHITE/EPOXY COMPOSITES-II**

PREPARED BY
K. N. LAURAITIS
P.E. SANDORFF

**LOCKHEED-CALIFORNIA COMPANY
BURBANK, CALIFORNIA**

FINAL REPORT
OCTOBER 1982

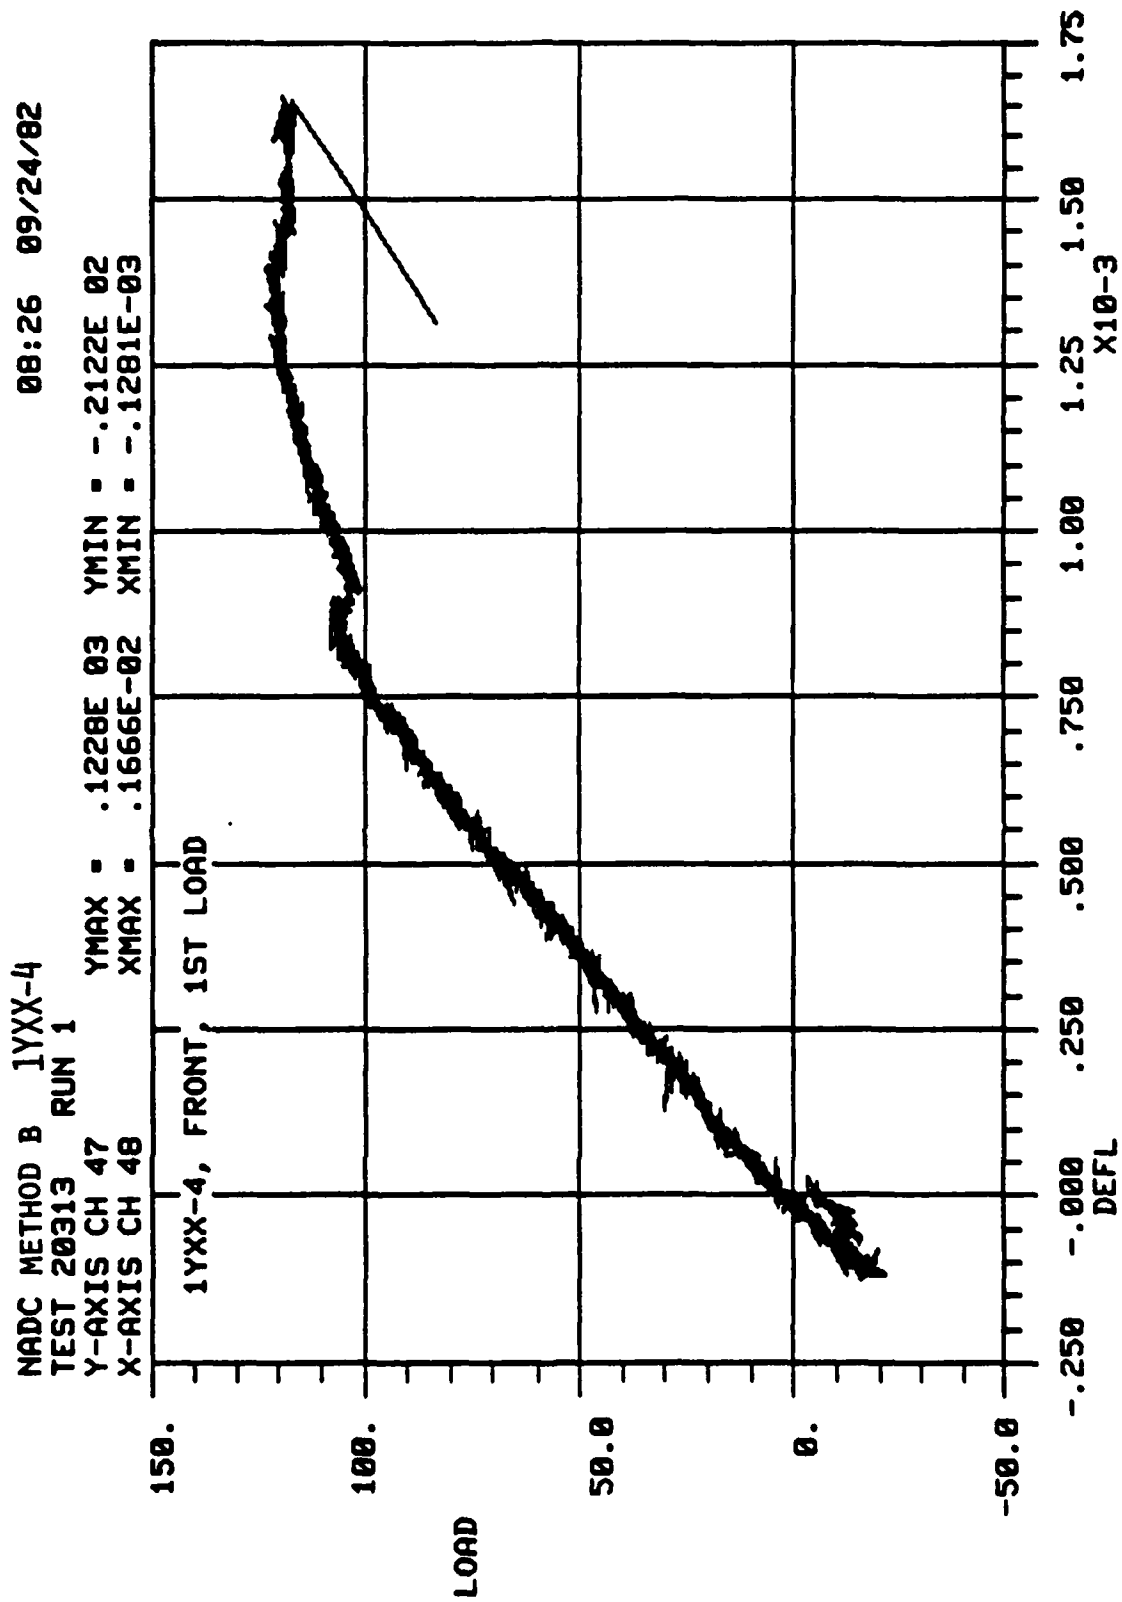
Figure 3.9a: Load vs. Crack Opening Displacement for Initial COD of 0.001 in. and Initial Crack Length of 0.9 in. - Front Gage

optical microscope mounted on the test machine because of the difficulty in seeing the crack tip under no load, a small load (approximately 25% of maximum load) was maintained while the crack length was read. Selected results for specimens with a debond between the 7th and 8th plies (2YXX-1) and those with a debond between the 3rd and 4th plies (1YXX-4) are presented in Figures 3.4 through 3.8 and Figures 3.9 through 3.11, respectively. Table 3.1 contains a tabulation of the complete test results.

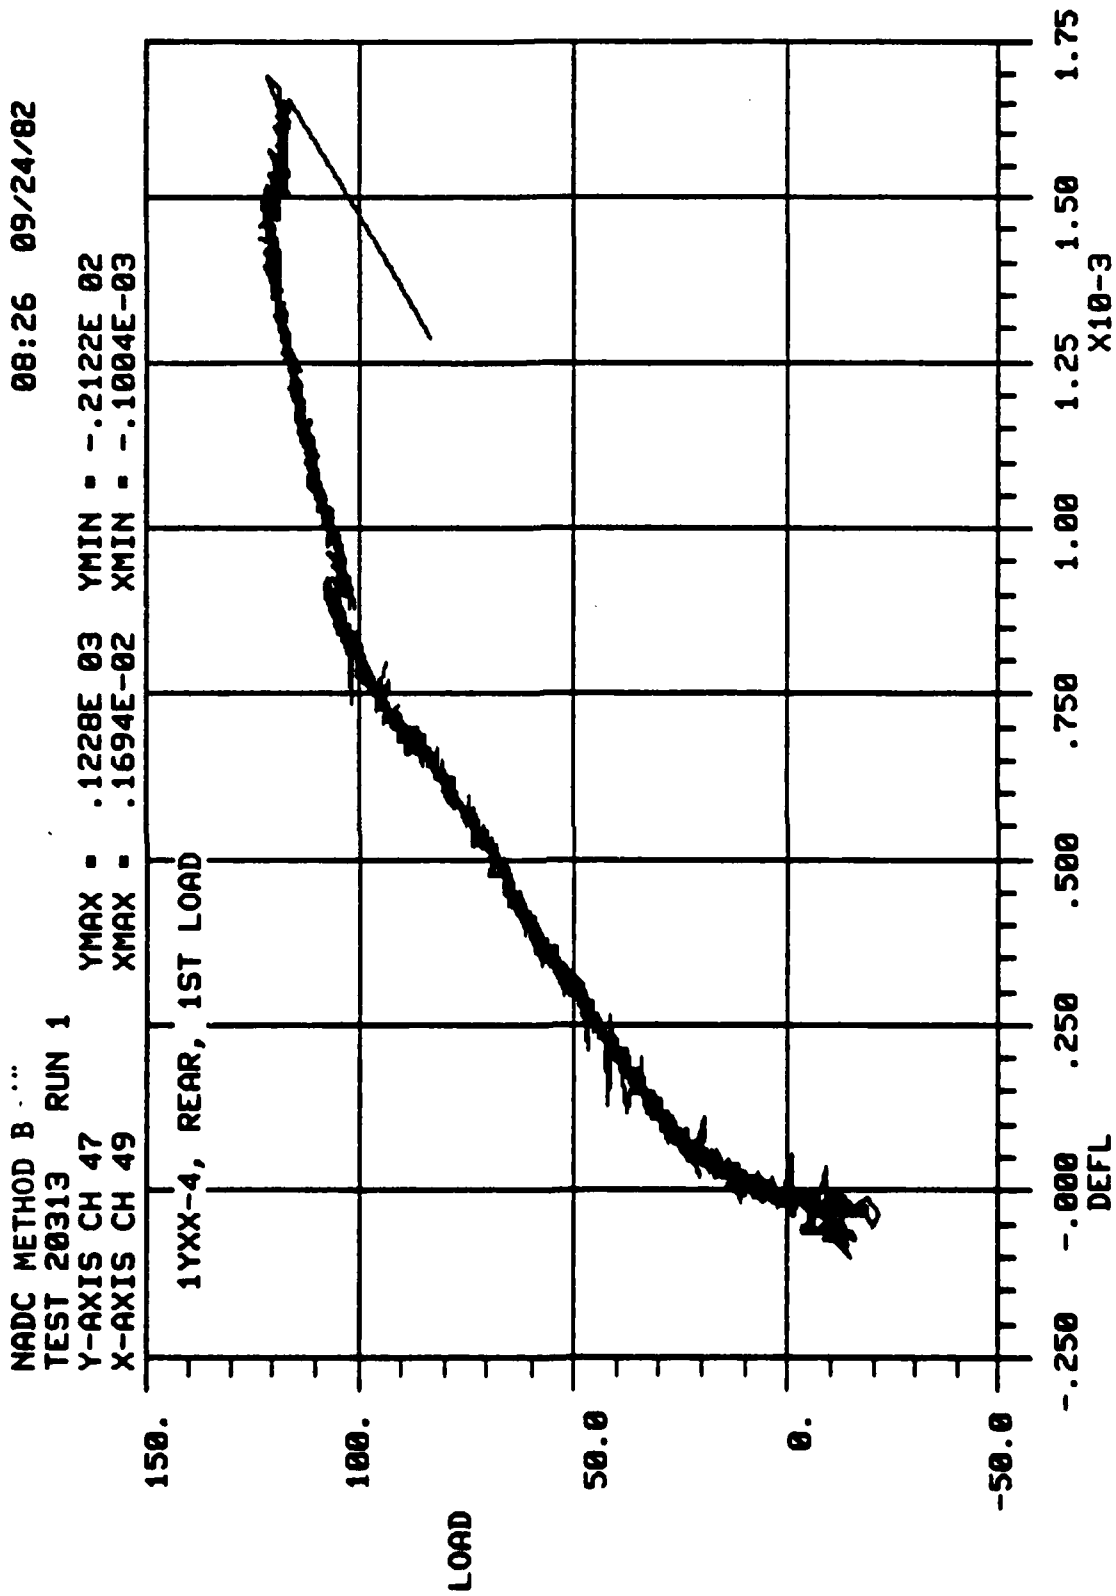
Figure 3.9b: Load vs. Crack Opening Displacement for Initial COD of 0.001 in. and Initial Crack Length of 0.9 in. - Rear Gage

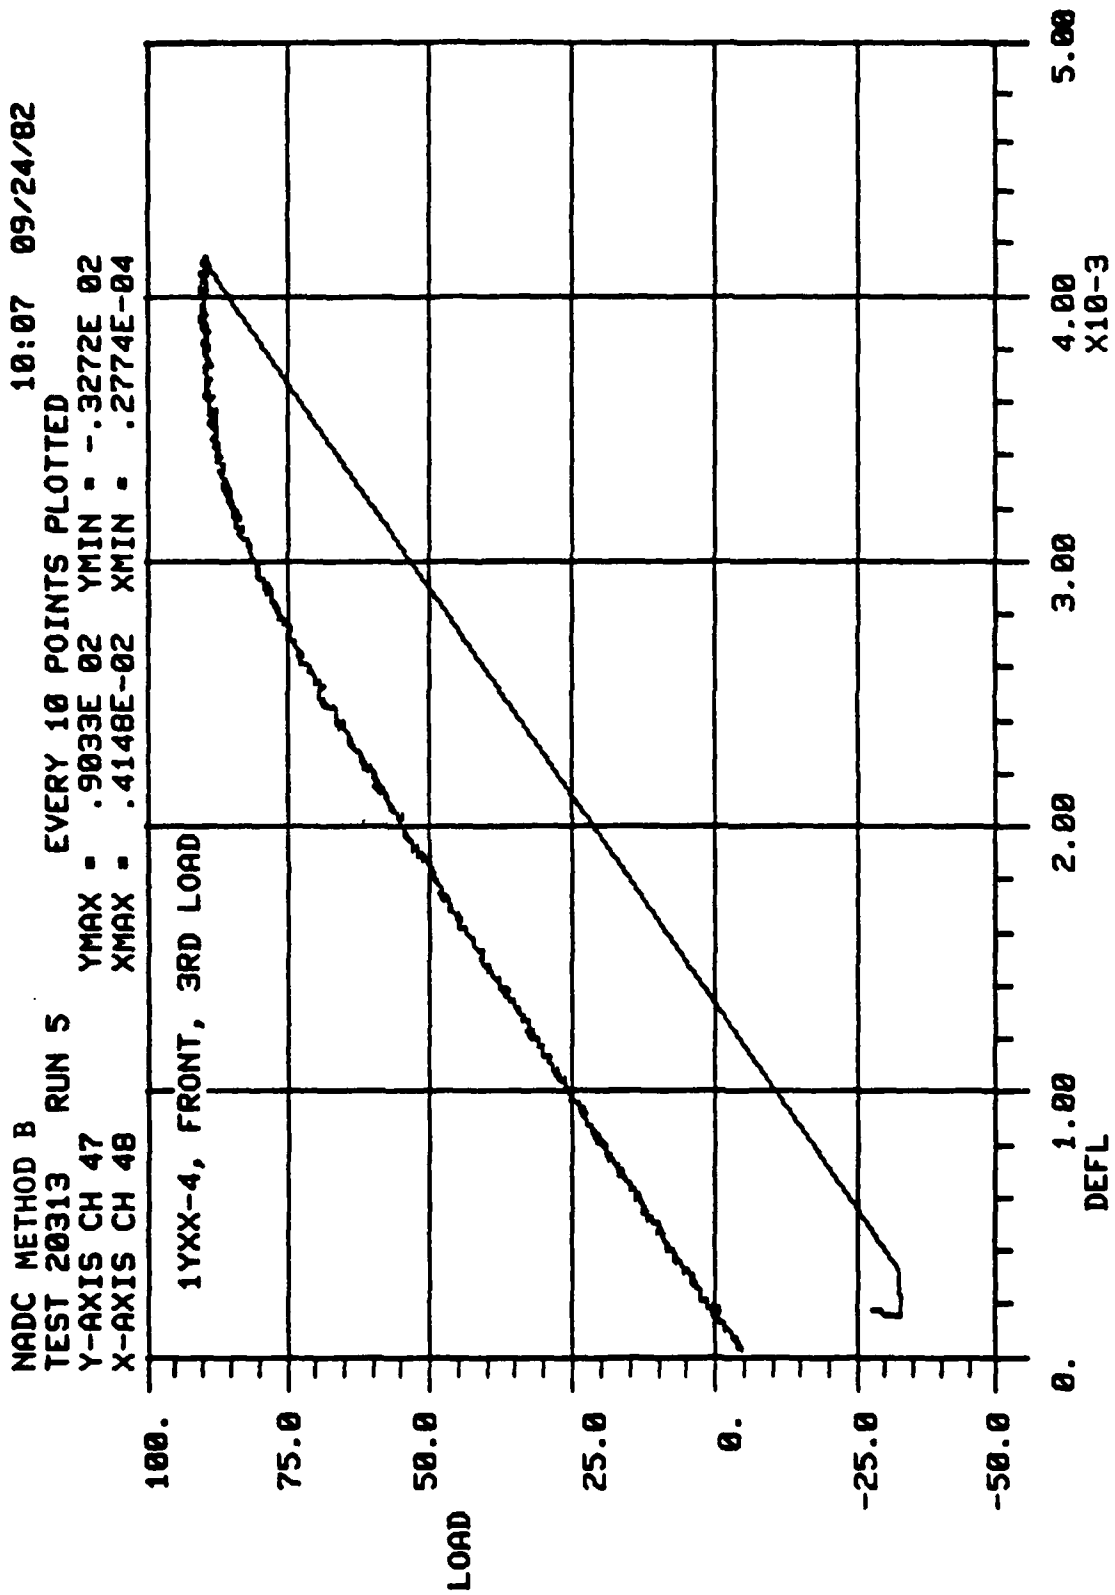
Figure 3.10a: Load vs. Crack Opening Displacement for Initial COD of 0.0013 in. and Initial Crack Length of 1.015 in. - Front Gage

NADC METHOD B RUN 5 10:07 09/24/82
TEST 20313 EVERY 10 POINTS PLOTTED
Y-AXIS CH 47 YMAX = .9033E 02 YMIN = -.3272E 02
X-AXIS CH 49 XMAX = .4102E-02 XMIN = .3655E-04

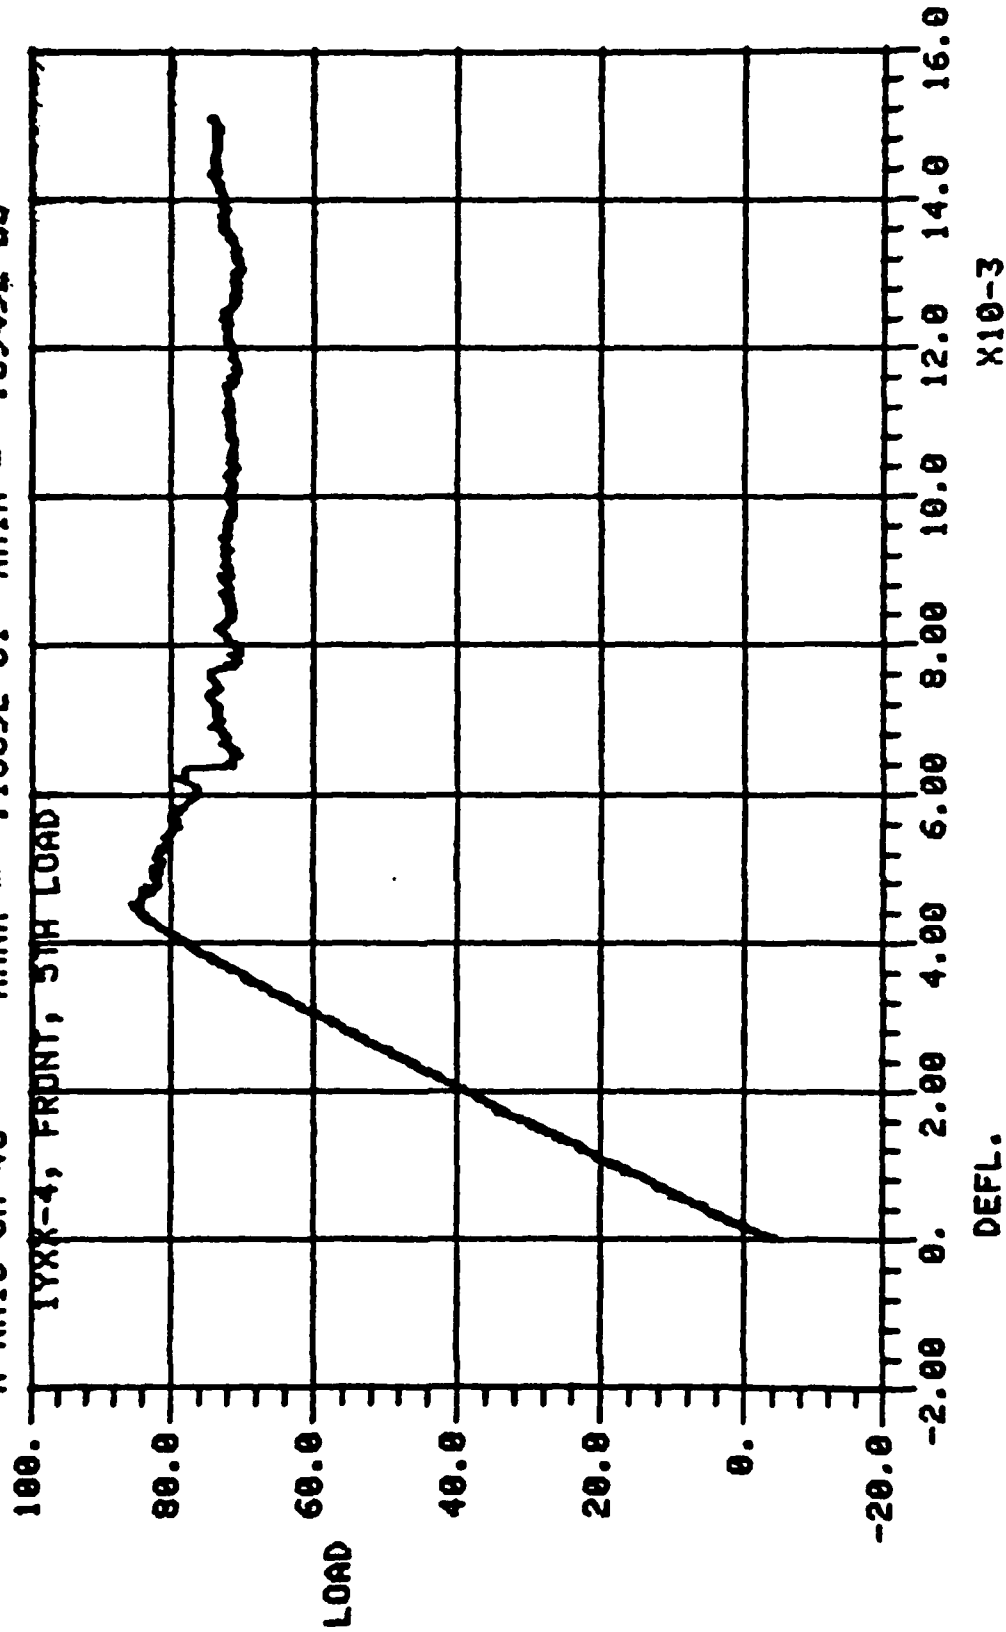
Figure 3.11a: Load vs. Crack Opening Displacement for Initial COD of 0.0016 in. and Initial
 Crack Length of 1.125 in. - Front Gage

NADC METHOD B RUN 9 EVERY 10 POINTS PLOTTED
 TEST 20313 YMAX = .8557E-02 YMIN = -.4517E-01
 Y-AXIS CH 47 XMAX = .1494E-01 XMIN = -.3641E-04
 X-AXIS CH 49

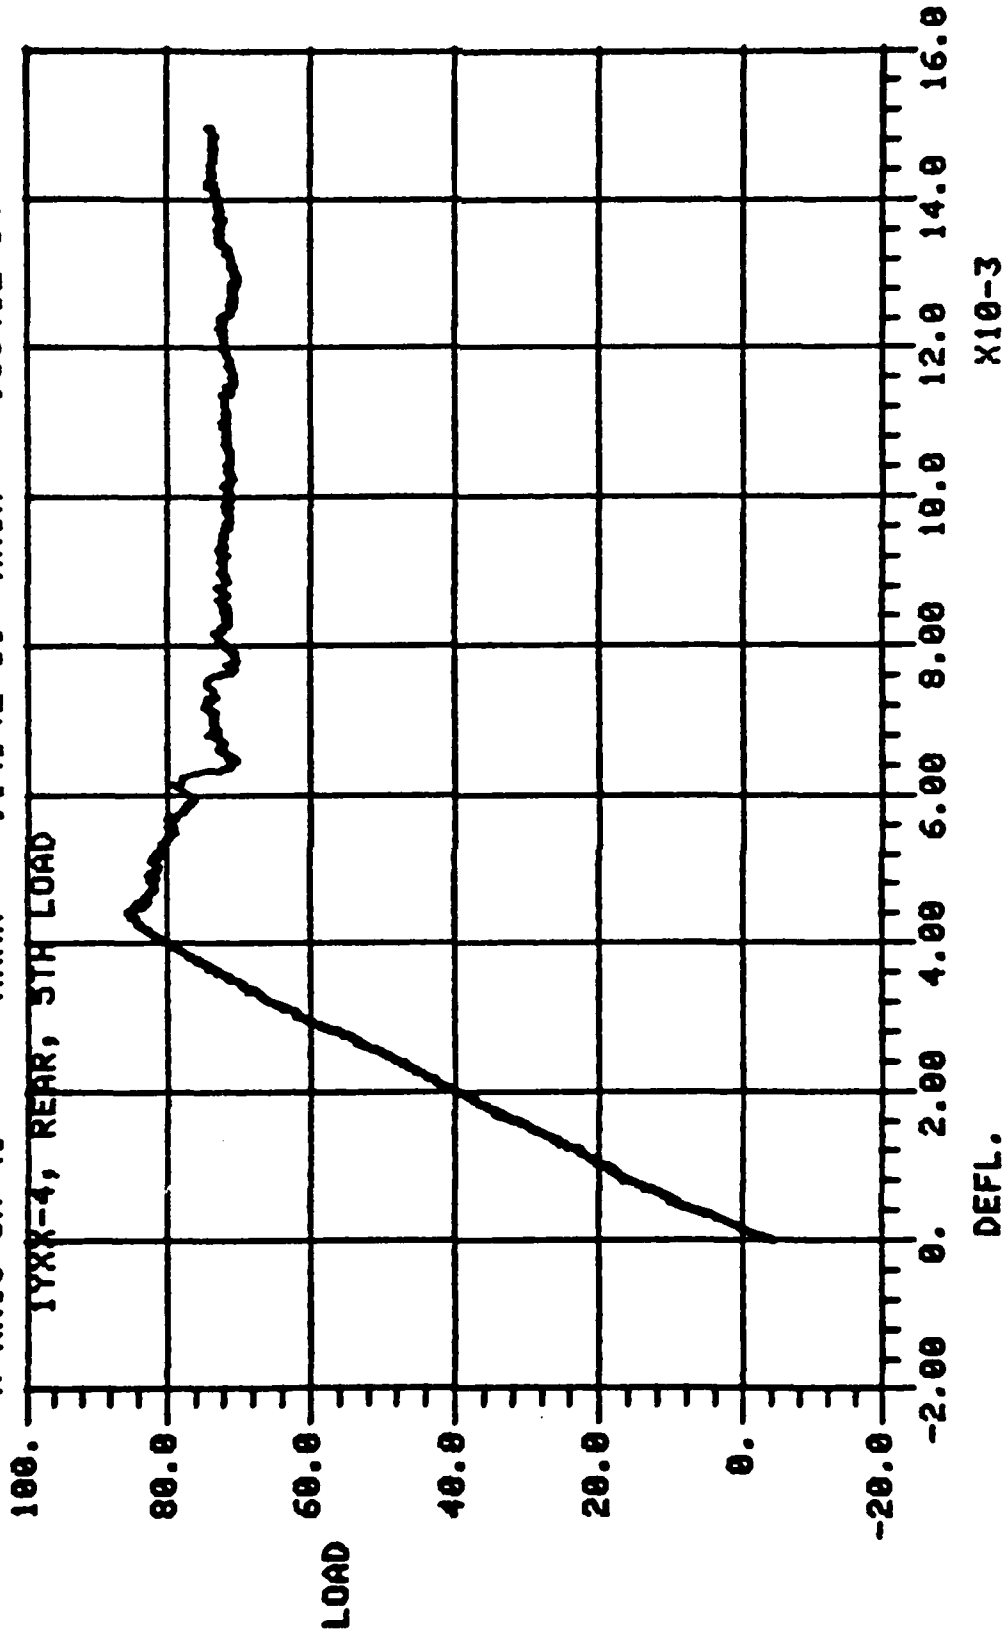
Figure 3.11b: Load vs. Crack Opening Displacement for Initial COD of 0.0016 in. and Initial Crack Length of 1.000 in. - Rear Gage

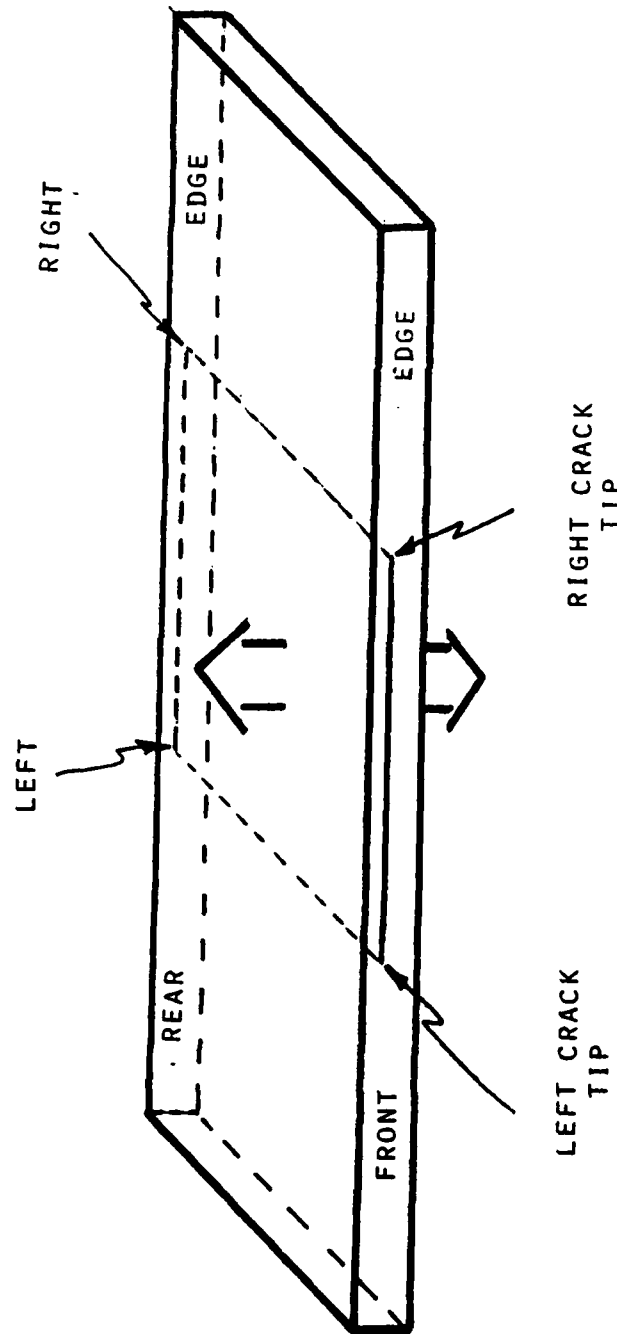
Figure 3.12: Crack Identification Used for Replicas - Figures 3.13 through 3.19.

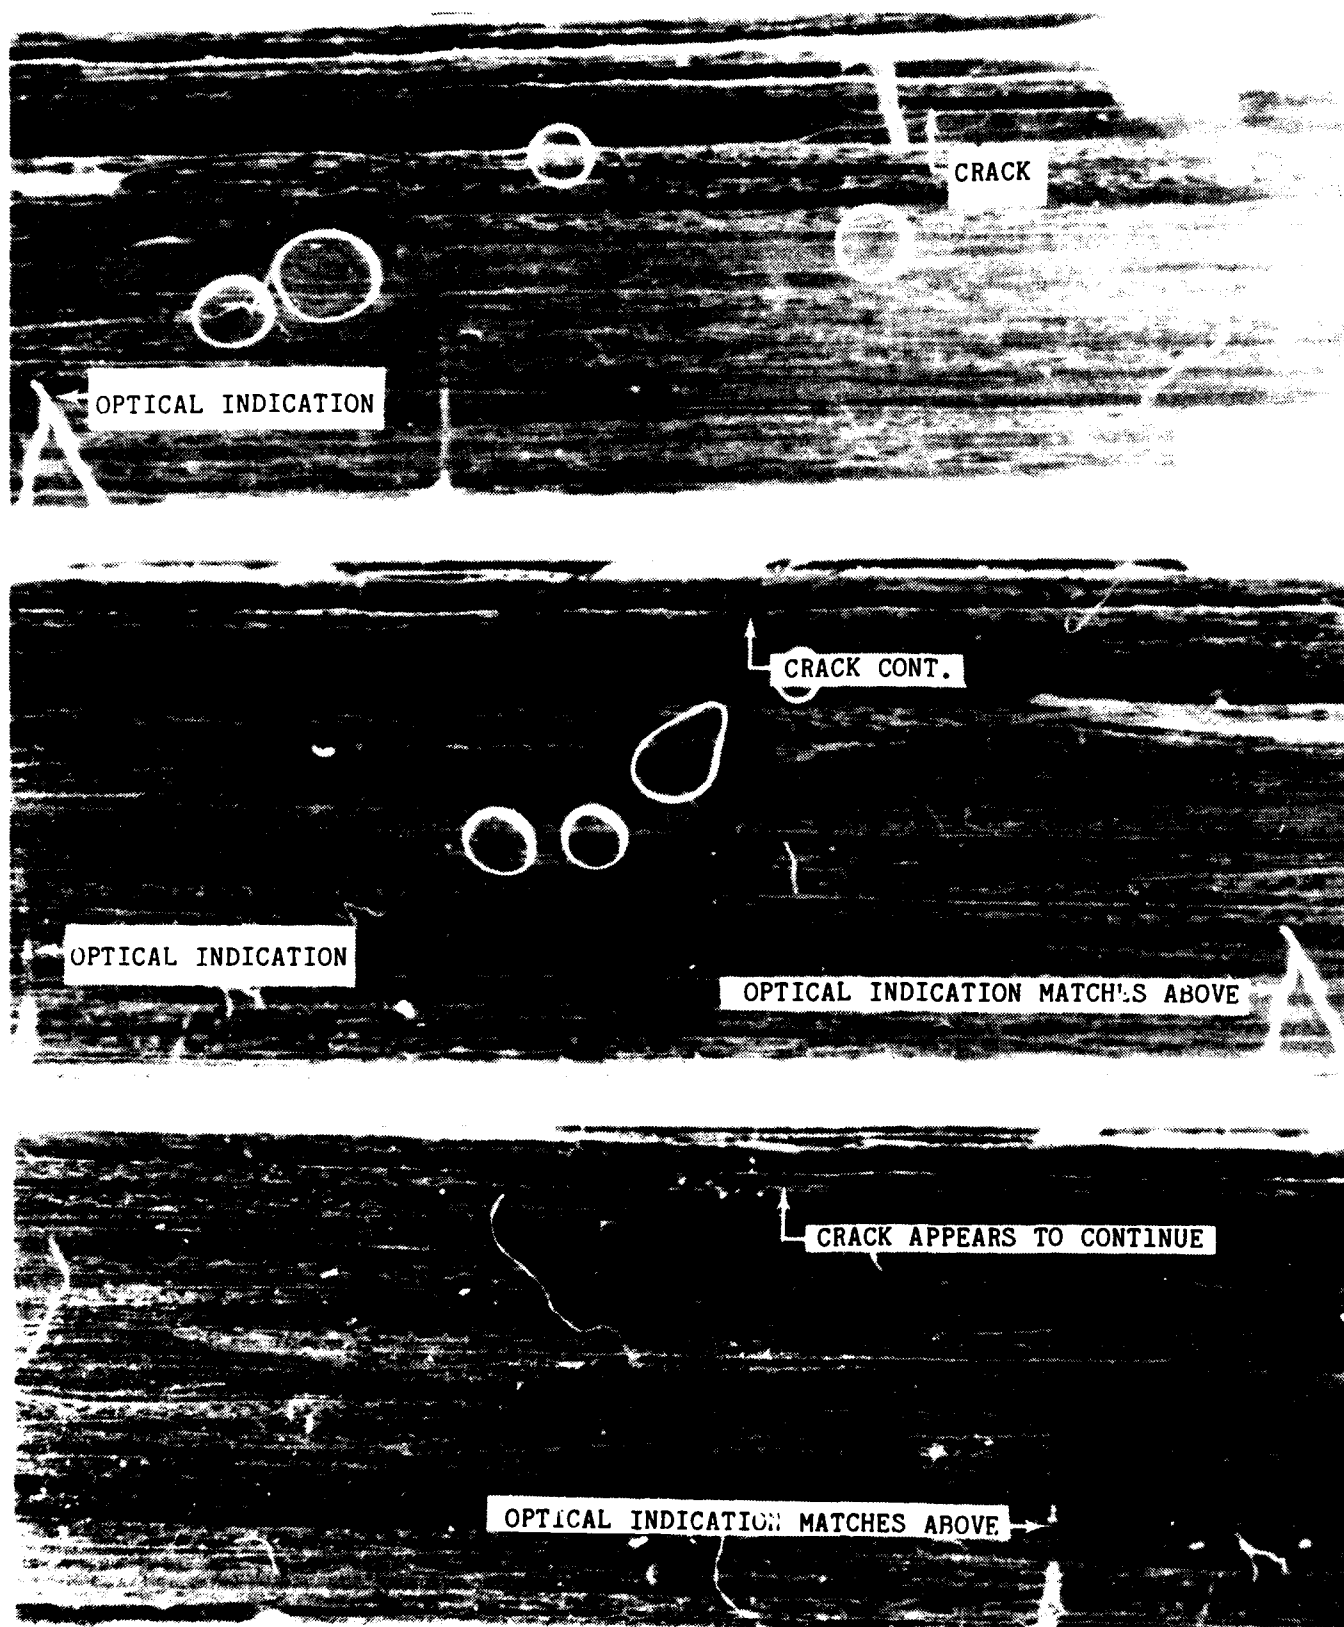
Figure 3.19: Replica of Left Crack Tip Front Edge of Specimen 1YXX-1 After 1100 Cycles.

crack tips were marked on the specimens. Acetate replicas of both specimen edges were then obtained for the four specimens. Water was injected into the cracks. Specimens were sealed and placed in a chamber with alternating -65°F and 160°F temperatures. After 1100 cycles, specimens were removed and edges replicated. Crack length measurements were made in the same manner as prior to the thermocycling. Crack length measurements made by optical microscopy once again indicated a change as shown in Table 3.2. However careful study of the edge replicas appears to indicate no change. Photographs of typical replicas are presented in Figures 3.13 through 3.19. The crack designations employed in these figures are illustrated in Figure 3.12. Cracks are much more clearly visible on the replicas than with direct observation by optical microscopy even with specimens under load. For example, in Figure 3.13 the location of the crack tip as determined by direct optical observation does not appear to coincide with the end of a crack on this replica. This was true for most of the observations. Figures 3.14 through 3.16 illustrate cases where there was good agreement for both methods of detection and for this specimen (1YXX-3) it is fairly clear that there has been no change. Crack tips were much more difficult to discern in the other specimens as shown in Figures 3.17 through 3.19, but in each case at least one specimen edge was readable. Again, these indicate no change.
